402 LEE STREET  
DECATUR, ALABAMA 35601  
May 9, 2024

Architectural Review Board

4:00 PM

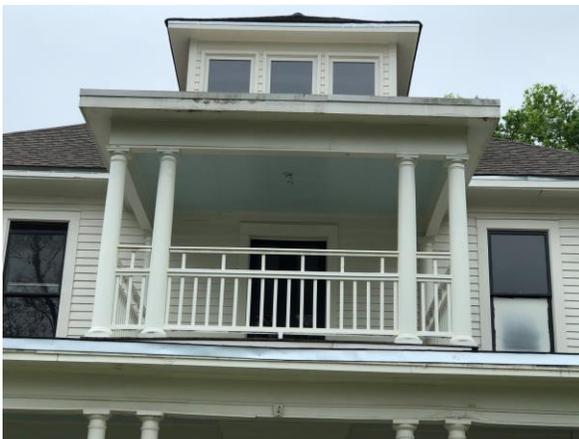
Example of an ARB required booster rail design to meet taller height requirements, 722 Ferry Street.

Railing Height: Historic porch railings were traditionally low, no higher than the top of the window sill. Because that height is lower than current code, the solution the commission has followed when a new or higher railing is requested is for the new railing to stop at the traditional low point, with an added booster rail above, providing a clear visual break between the historic railing height and one currently desired.

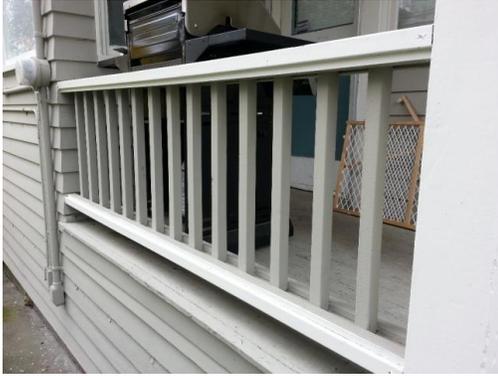
Example of a simple railing design used when a house doesn't have a defined architectural style that requires strong stylistic matches.

Design: This early 20<sup>th</sup> century house is a vernacular structure with few stylistic details. For other examples of this style, the board has required that railings be the traditional slender square posts, with no elaborate styling details.
